TRUXTUN COVE UPLAND ASSESSMENT

North Green Tennis Court: Submerged Gravel Wetland FINAL Concept

North Green Pool: Bioretention

FINAL Concept

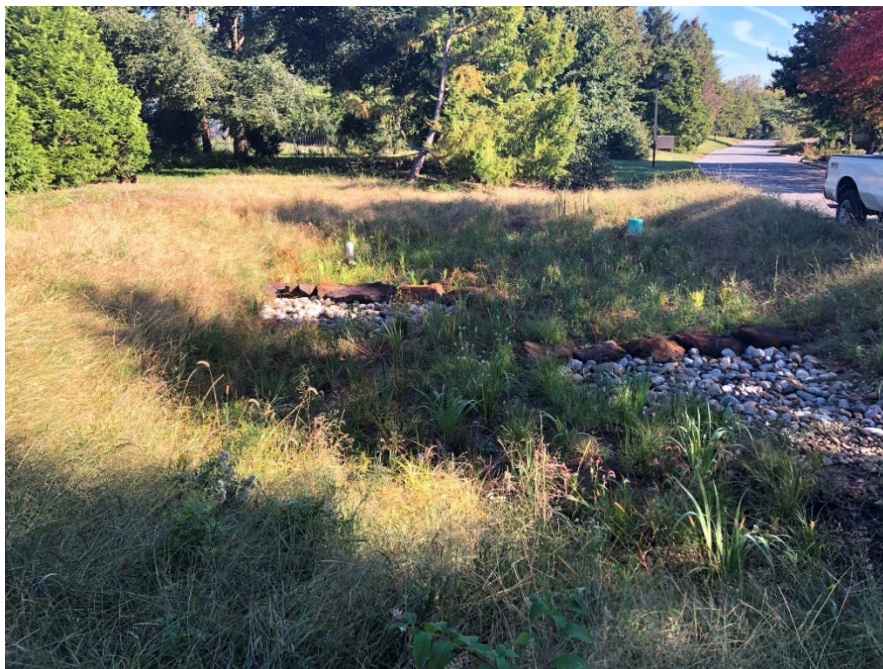
Figure 2. Example of submerged gravel wetland in Washington, D.C.

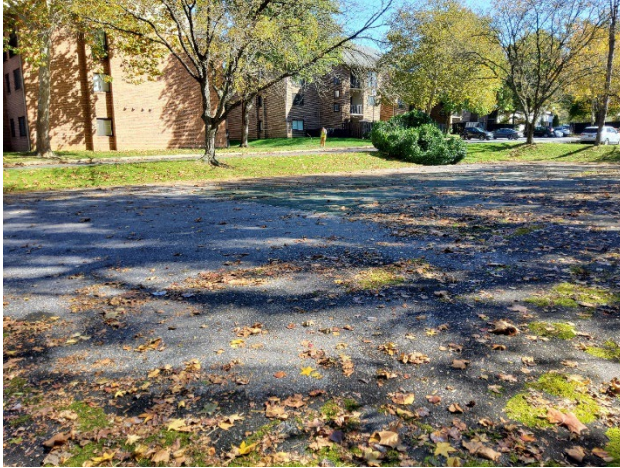
Photo 1. Remnant tennis court looking southeast toward existing North Green Condominium.

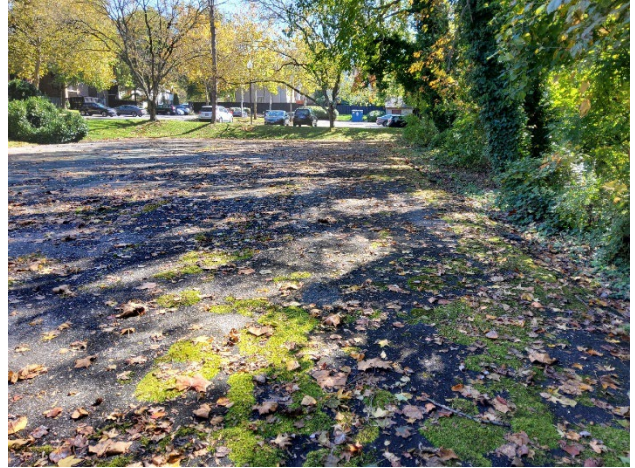
Photo 2. Remnant tennis court looking southeast toward existing parking lot with existing tree line to the southwest.

Stormwater currently flowing into the stormdrain network from the existing parking lot to the southeast would be redirected into the submerged gravel wetland and discharge back into the stormdrain network to the north. Given the large area, the submerged gravel wetland could take on additional stormwater inputs from residential areas to the southeast that currently discharge directly into the stream adjacent to the retrofit facility.

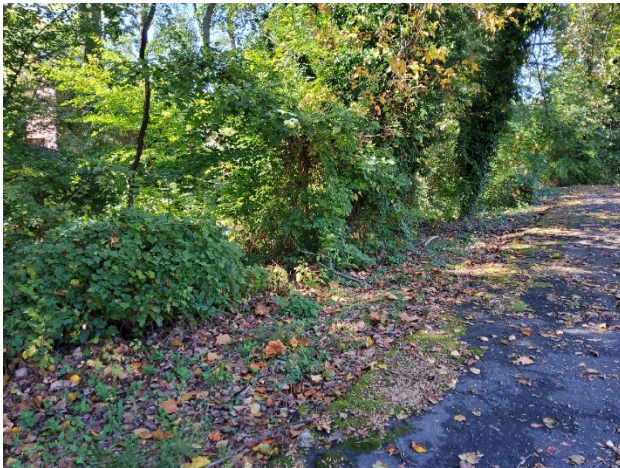
The proposed stormwater retrofit is located at a remnant tennis court facility within the North Green Condominium neighborhood in Annapolis, MD. The remnant tennis court is bound by an existing stream channel to the southwest, Gemini Drive to the north, condominiums to the east, and an existing parking lot to the southeast. An existing tree line follows the length of the tennis court to the southwest as well as several invasive species such as English ivy.

Photo 3. Looking northwest toward the invasive species and tree line to the southwest of the remnant tennis court.

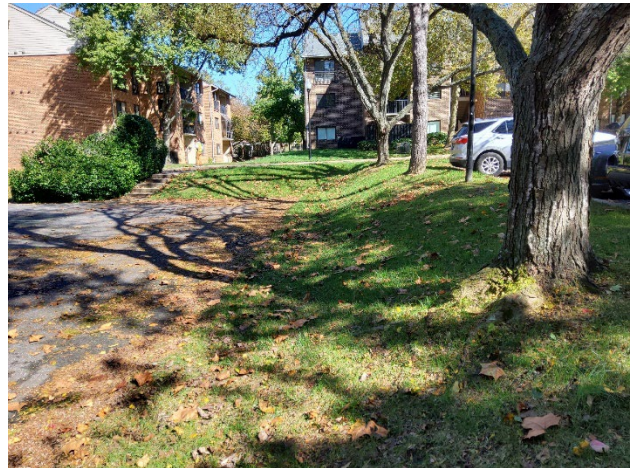
Photo 4. Looking northeast toward existing North Green Condominium with existing parking lot to the southeast and the remnant tennis court to the northwest.

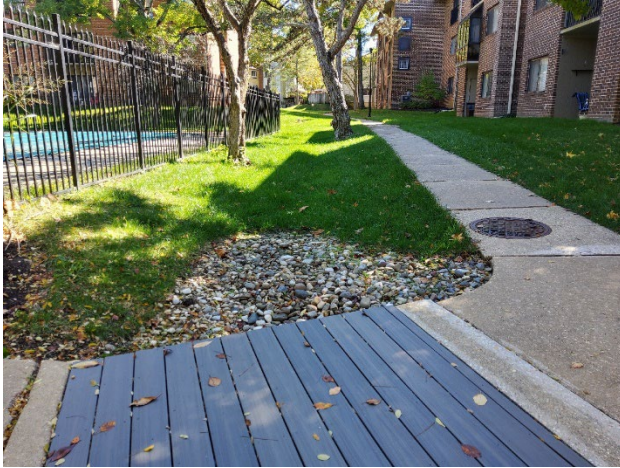
Photo 1. Existing swale on the south side of pool.

The proposed bioretention surrounds the pool to the north, east, and south and is located within an existing swale. An existing storm drain outfall is located on the southwest side of the pool and will be used to capture overflow from the micro-bioretention. Underground electrical lines supporting light poles were identified along the adjacent sidewalk. The surrounding soils are classified as C soils indicating a slow infiltration rate when thoroughly wet.

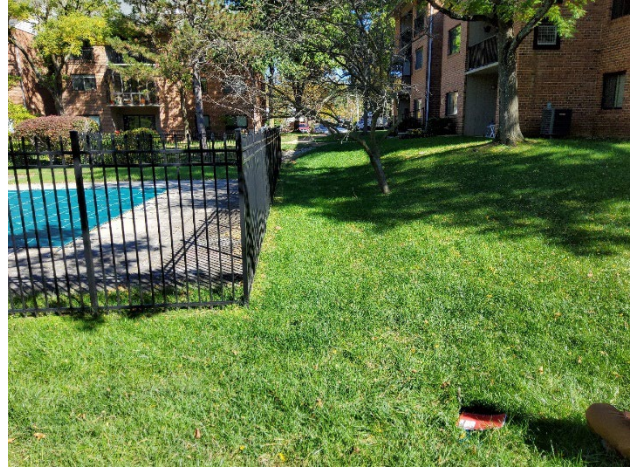
Photo 2. Existing swale on the east side of pool.

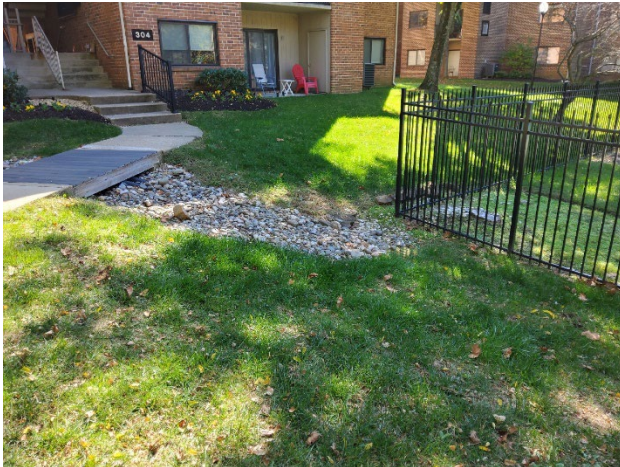
Access:	From a parking lot drive aisle off Gemini Drive
Staging:	Parking lot on the abandoned tennis court
Land Ownership:	North Green Condominium Association
Environmental Resources:	4 individual trees in poor condition
Utilities:	Underground electric (i.e., light poles)
Other Constraints:	Small area of erosion on steep slope on NE corner; should include planting in design to mitigate

Photo 3. Eroded slope on northeast side of pool.

A bioretention is a filtering practice using plants, soil media and stone to capture stormwater runoff and remove pollutants through settling, soil adsorption, and microbiological and plant uptake. Stormwater currently passing into the existing swale includes runoff generated from sidewalks, the pool deck, and rooftops. An underground pipe at the bottom of the practice will allow drainage to flow through the system and will take excess drainage into the existing storm drain system. An overflow device in the system will allow drainage during larger storm events to bypass the system and safely pass into the storm drain system. The design should include planting of an eroded slope on the northeast side of the pool.

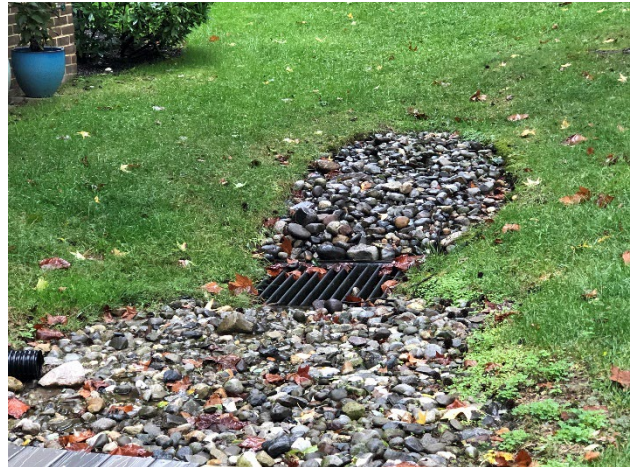
Photo 4. Existing inlet to be converted to proposed overflow.
